ACOUSTICAL PERFORMANCE TEST REPORT

ODL, INC.

SERIES/MODEL: Harmony Blind with Internal Muntins

TYPE: Triple Pane Insulated Door Glass Unit

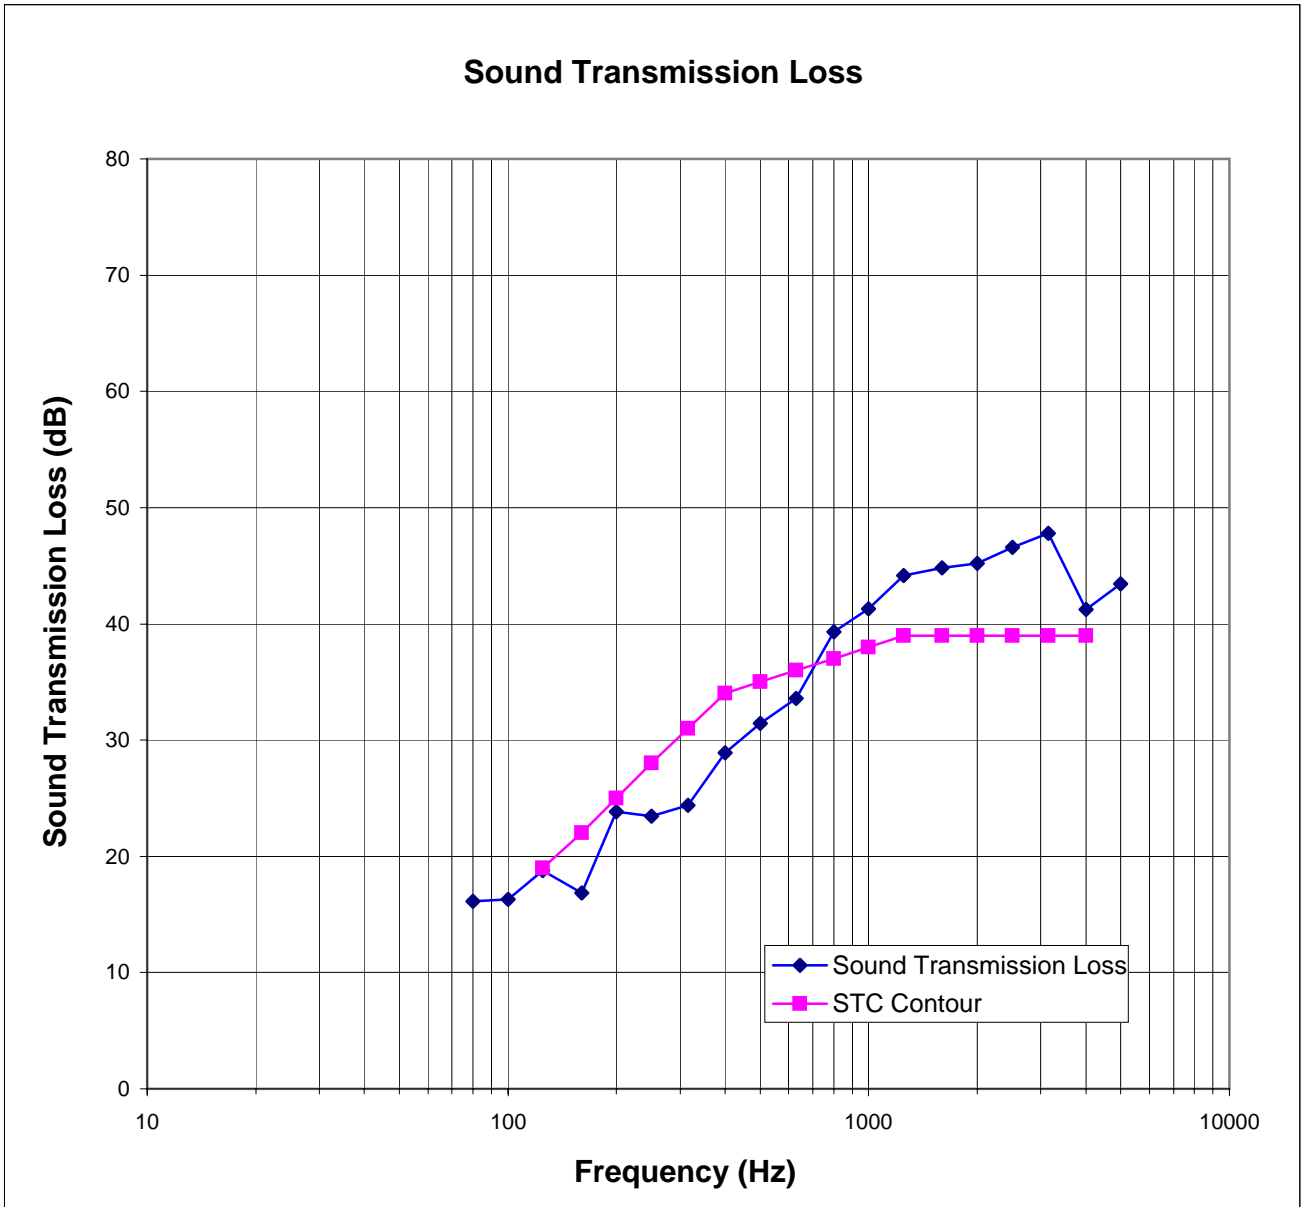
ATI No. 75652.01A Date 08/17/07
Client ODL, Inc
Specimen Series/Model Harmony blind glass unit with internal muntins. Triple glazed with 1/8" tempered, blinds raised and stacked at top
Specimen Area 6.23 Sq Ft
Filler Area 133.77 Sq Ft
Operator Brandon C. Ward

STC Rating = 35 *(Sound Transmission Class)*
Deficiencies = 29 *(Number of deficiencies versus contour curve)*
OITC Rating = 26 *(Outdoor/Indoor Transmission Class)*

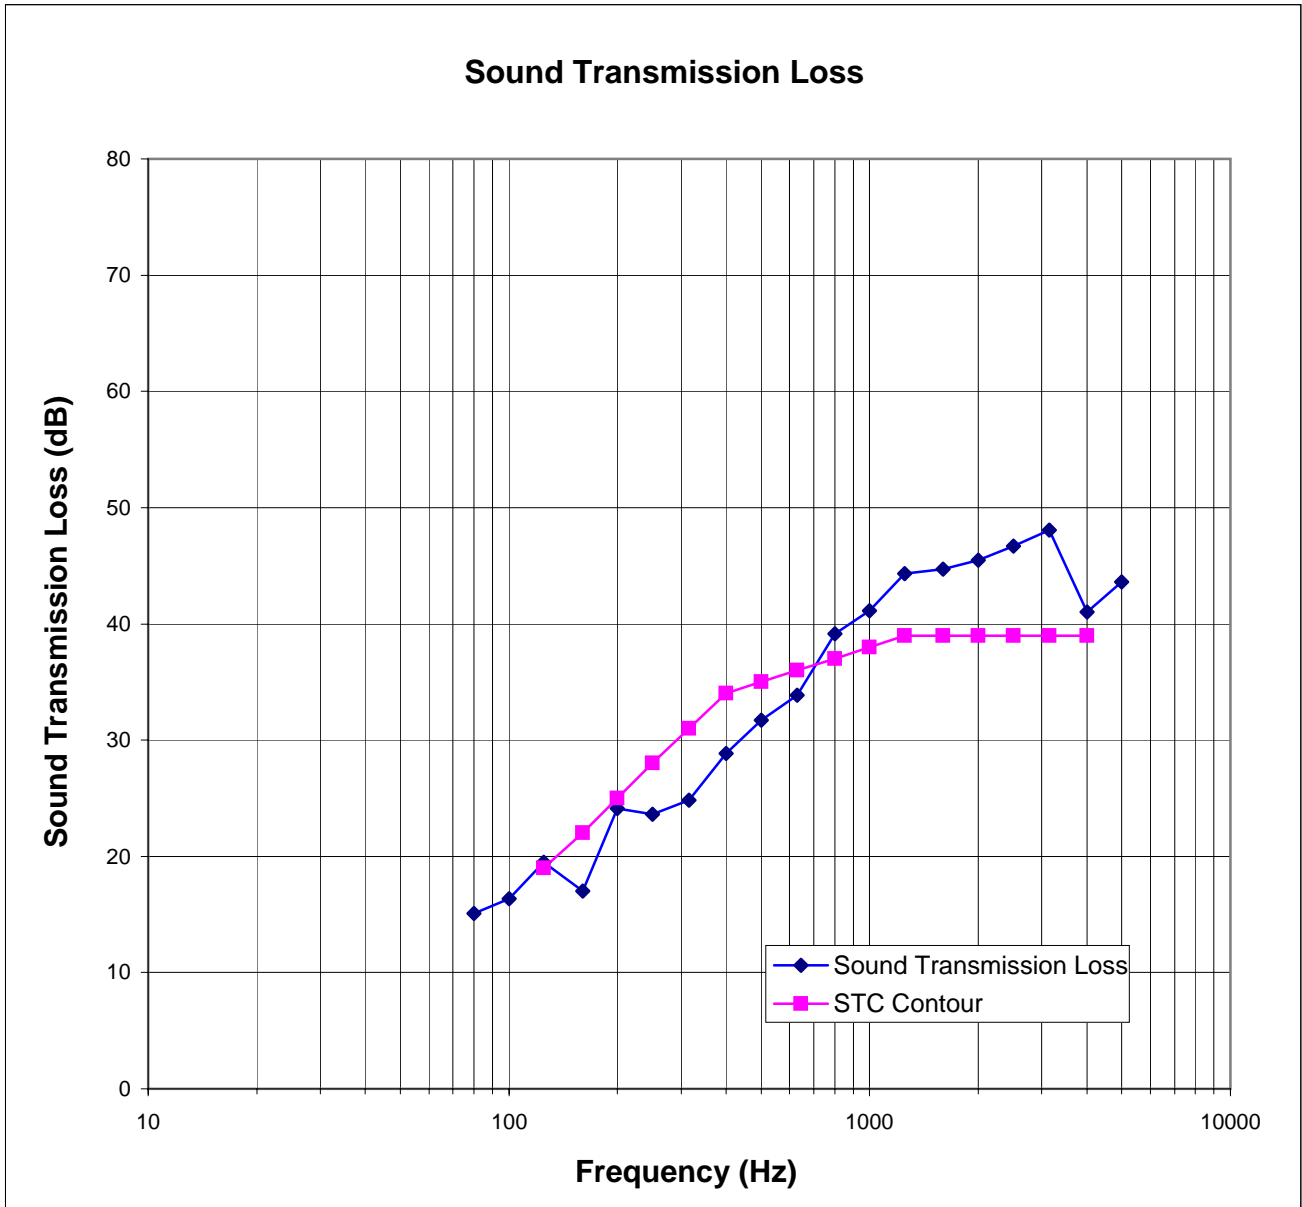
ATI No. 75652.01B Date 08/17/07
Client ODL, Inc
Specimen Series/Model Harmony blind glass unit with internal muntins. Triple glazed with 1/8" annealed blinds lowered and closed
Specimen Area 6.23 Sq Ft
Filler Area 133.77 Sq Ft
Operator Brandon C. Ward

STC Rating = 35 *(Sound Transmission Class)*
Deficiencies = 26 *(Number of deficiencies versus contour curve)*
OITC Rating = 26 *(Outdoor/Indoor Transmission Class)*

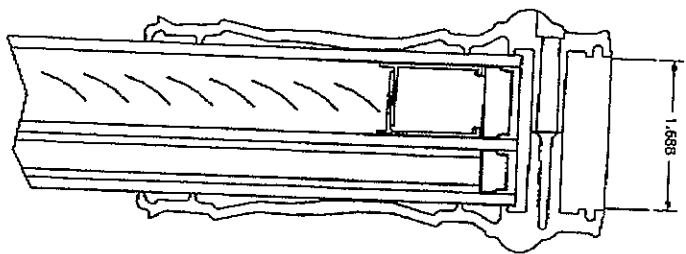
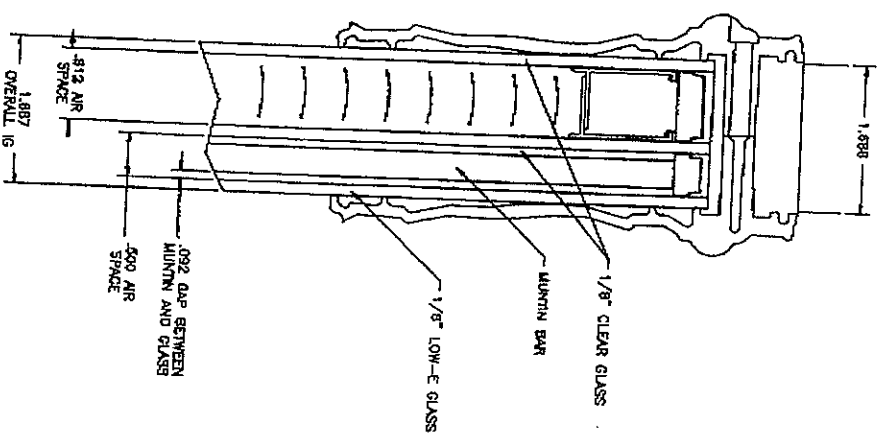
Appendix C
Design Drawings

Test sample complies with these details.
Deviations are noted.

SLAT WIDTH: .590"
SLAT THICKNESS: .008"
SLAT MATERIAL: ALUMINUM

Comments: The triple pane insulating door glass unit contained an internal blind system located in the 0.806", interior air space. For option A the blinds were fully raised and stacked. For option B the blinds were fully lowered and closed. The triple pane insulating door glass unit was sampled and will be retained by ATI for four years. Drawings of the test sample are located in Appendix C. Photographs of the test sample are located in Appendix D.

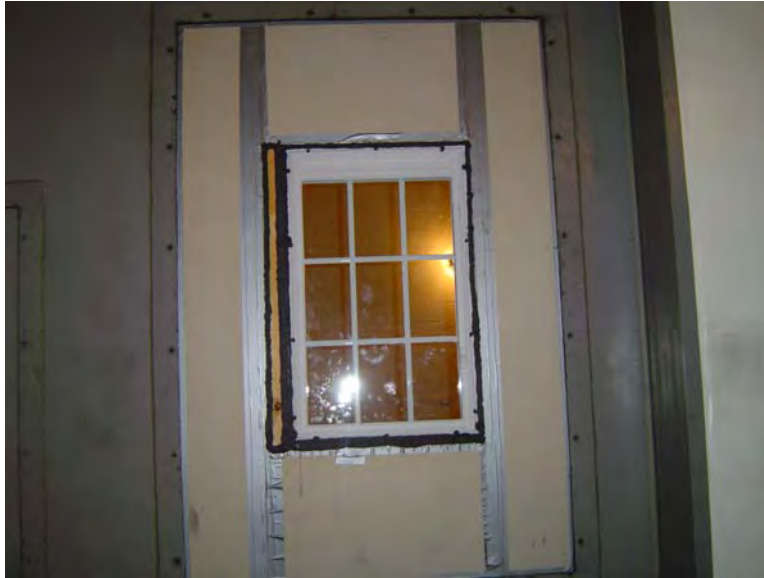
Interior of Sample Installed in Test Opening (Blinds Raised and Stacked)

The 48" by 72" plug was removed from the filler wall assembly and a custom adapter plug was constructed to reduce the test opening size to 24-1/4" wide by 38-1/4" high. The adapter plug consisted of a double 2x4 wood stud wall with three layers of 5/8" gypsum board covering both sides. The double wood stud wall was insulated with two layers of 3-1/2" thick fiberglass insulation. A dense neoprene gasket and duct seal was used to seal the custom adapter plug to the inside perimeter of the filler wall opening. The door glass unit was installed in the test opening. Duct seal was used to seal the frame of the door glass unit to the test opening. The interior side of the door glass unit, when installed, was approximately 1/4" from being flush with the receiving room side of the filler wall. A stethoscope was used to check for any abnormal air leaks before the test.

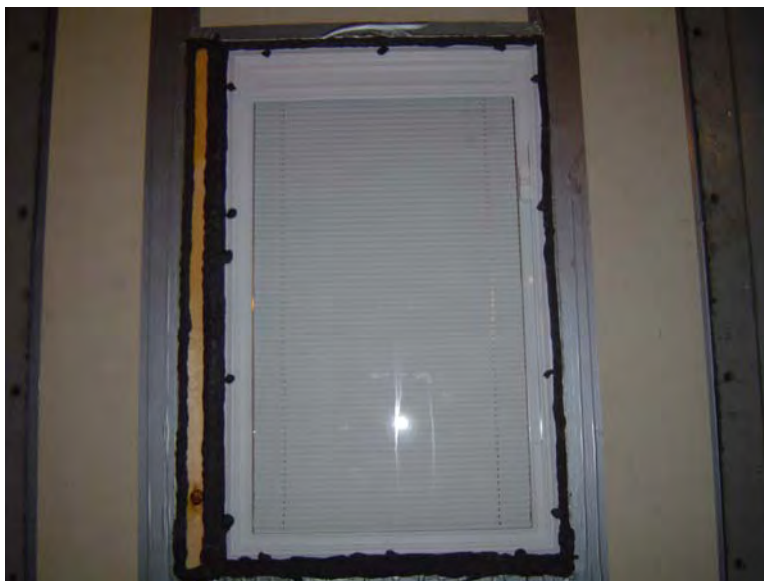
Interior of Sample Installed in Test Opening (Blinds Lowered and Closed)
